Thermal Scanning Report

Description: Thermal Energy Loss Comparison – A Qualitative Survey

HomeCreete Homes Project Locations:
4080 Edisto Dr. Grant, Florida
3036 SW Ellsworth Ave, Palm City Florida
225 Bayshore Drive, Port St Lucie Florida
3771 SW Savona Blvd Port St Lucie Florida

Thermal Scanning Report
 Thermal Energy Loss Comparison

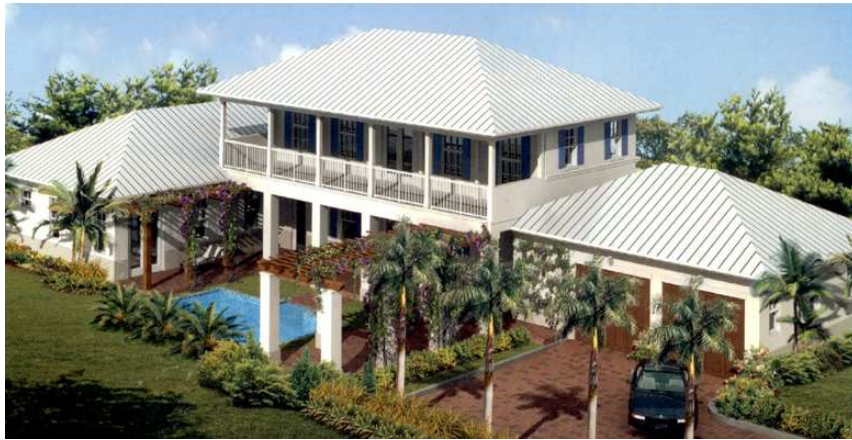
Infrared Image #1

ICF Construction:

Thermal image shows very little heat loss of this two story home on a cold night as indicated by the darker colors of the exterior walls.

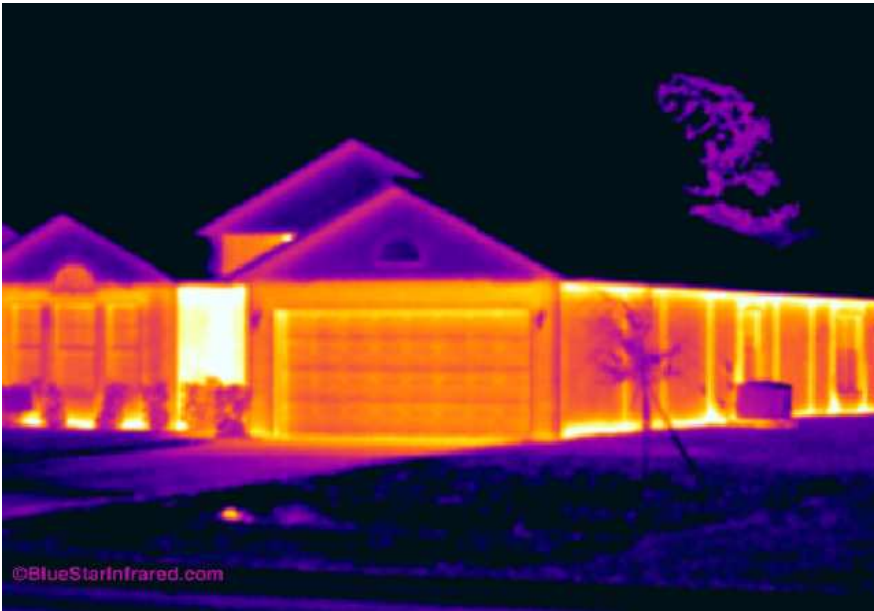
Infrared Image #4

CBS Construction:

The many areas of lighter colors in this thermal image of a single story, CBS home illustrates the low insulating value of this type of construction, resulting in increased energy consumption through out the year.

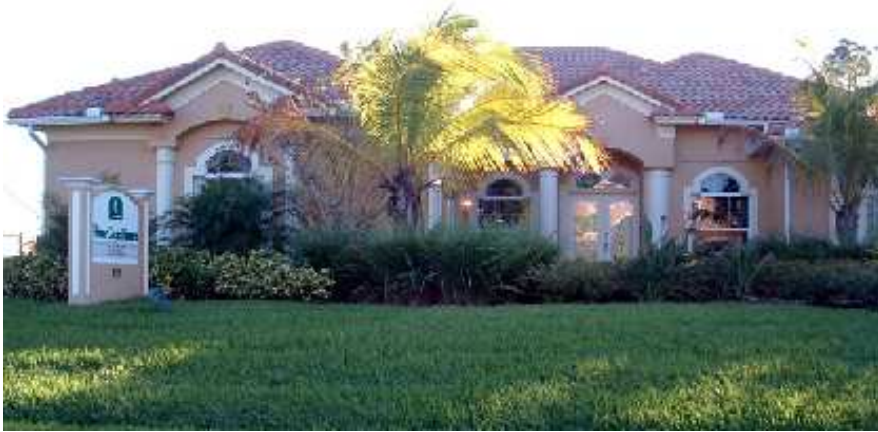
Infrared Image #5

ICF Construction:

The darker colors of this ICF home, illustrates the high insulating value of the exterior walls which substantially reduces heating and cooling energy consumption year round.

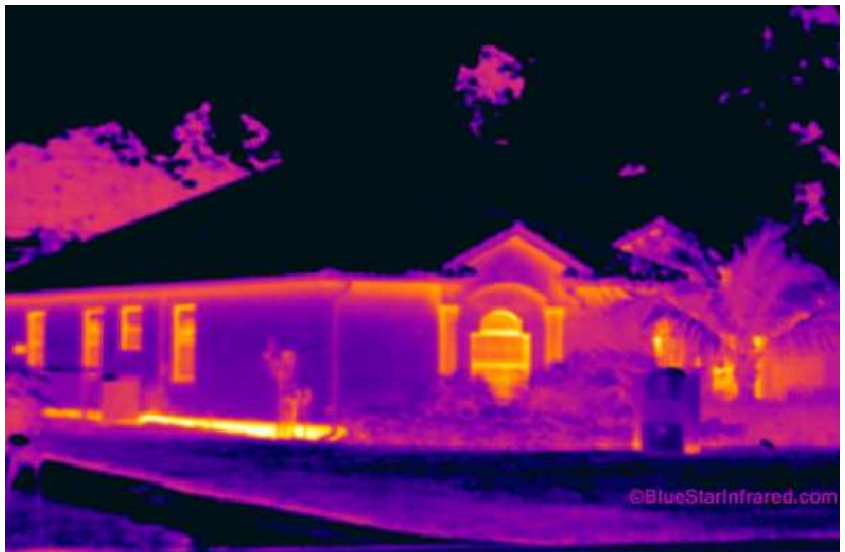
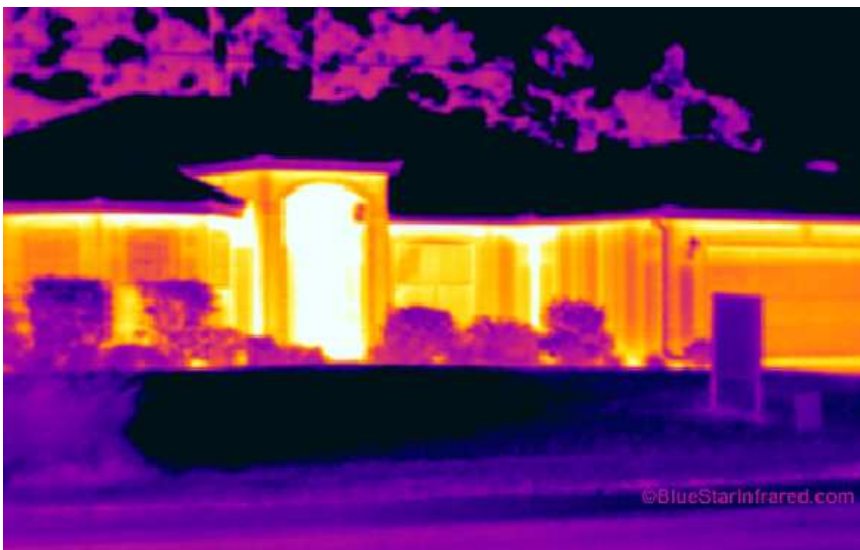
Infrared Image #6

CBS Construction:

Thermal image of a comparable, single story, CBS home highlighting the poor insulating value of this type of construction that will substantially increase energy consumption in both the cooling and heating seasons.

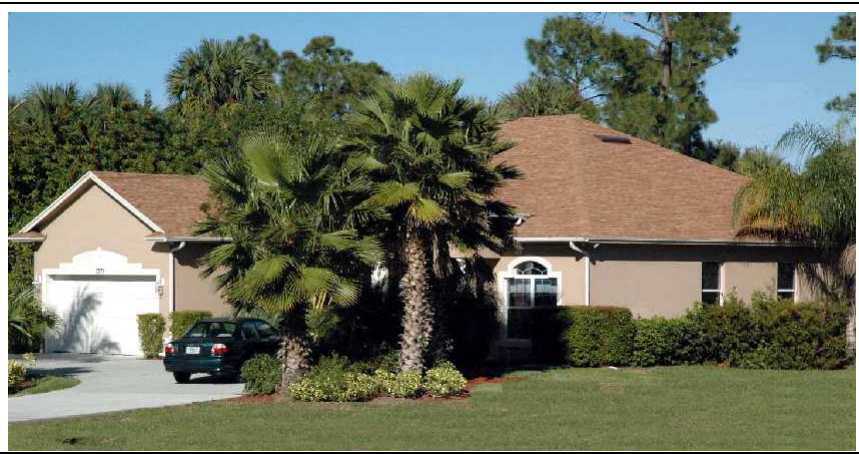
Infrared Image #7

ICF Construction:
 The high insulating quality of the ICF type construction used in this home is evident by the darker colors of the walls which will substantially reduce energy consumption.

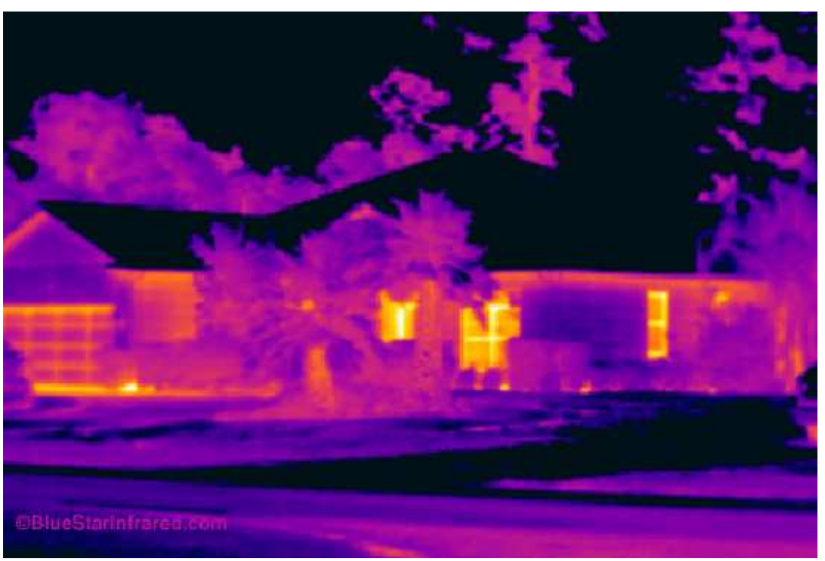
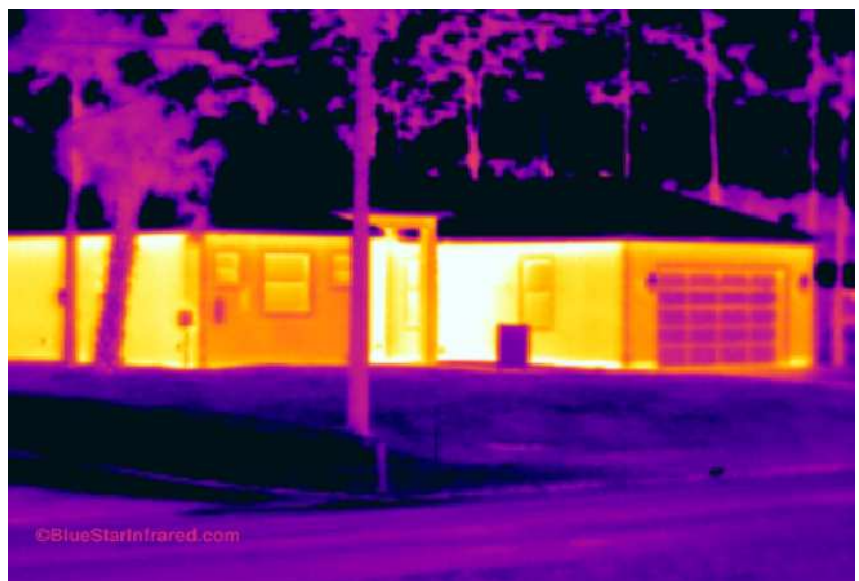
Infrared Image #8

CBS Construction:
 The brighter colors in this thermal image of a standard CBS home indicate many areas of substantial energy loss.

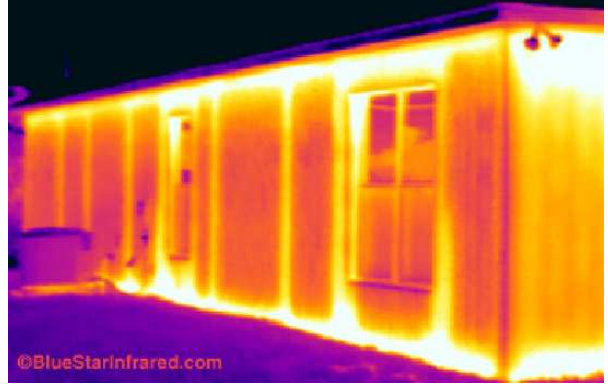
Infrared Image #10

The exterior walls of this CBS type construction home are poorly insulated and wasting energy

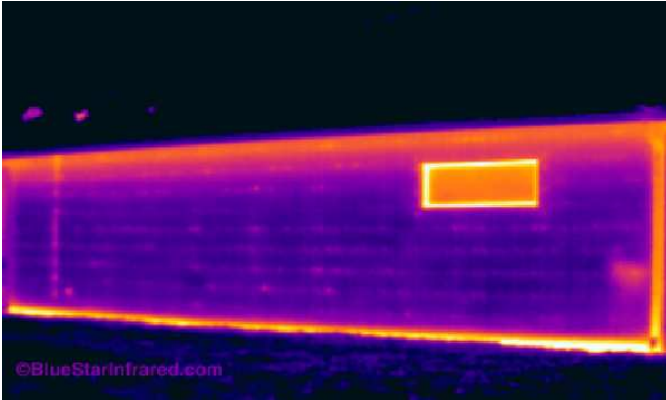
Infrared Image #11

Thermal Image of this home illustrates the energy efficient quality of its ICF construction.

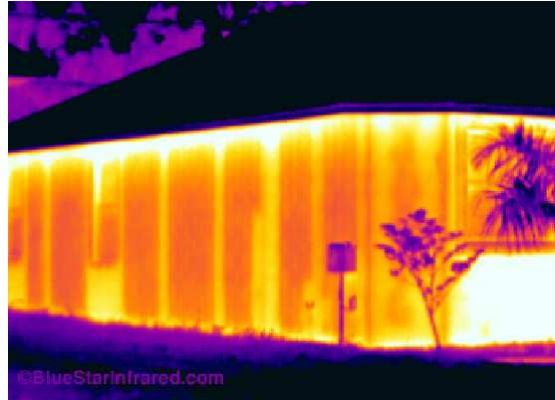
Infrared Image #12

Thermal image highlighting energy loss typical of standard CBS type construction.

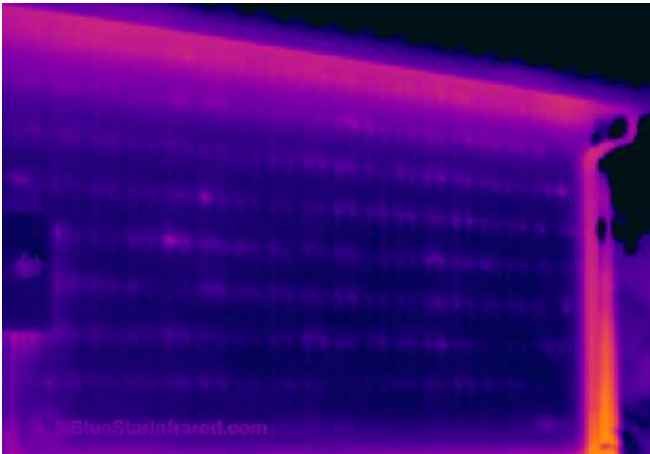
Infrared Image #13

Close-up thermal image of an exterior, ICF wall illustrating a remarkable lack of energy loss.
